# Manhole Inspection Summary

Manhole # S11QQ1005MH

**Location** Address: **2712 CYLBURN AVE**

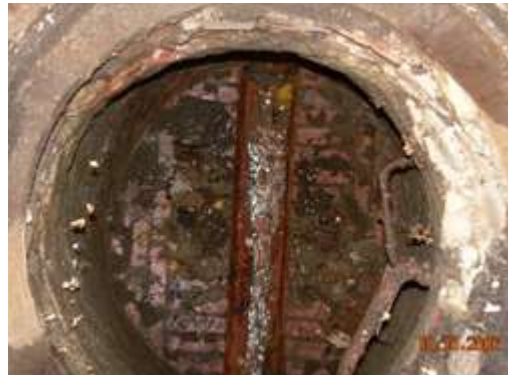
Top View

Frame leaks. Evidence of surcharge - Bench debris. Corroded steps.

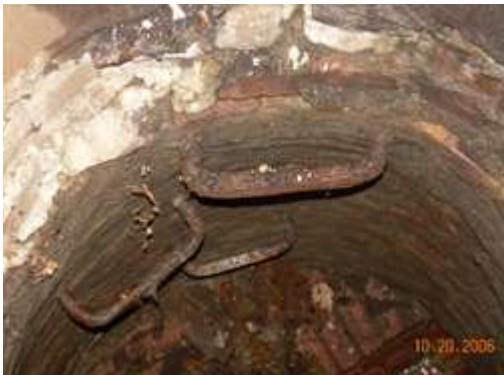
Defect

Corroded steps. Frame offset. Adjustment deterioration and infiltration. Corbel and Barrel infiltration.

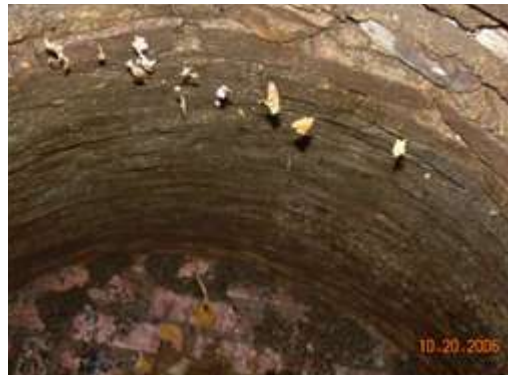
Defect

Adjustment deterioration and infiltration. Corbel infiltration. Barrel root intrusion and infiltration.

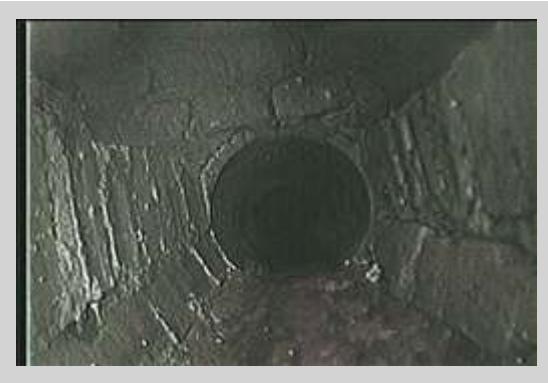
### 8 in. Circular Gravity Sewer Pipe Out @ 12 O'Clock

Comments **The O12 pipe picture shows Channel deterioration.**

Barrel deterioration and infiltration. Channel deterioration.

Infiltration: **Evidence** Pipe Seal Cond: **Unknown**
